Inspection Report

Property Address:
0000 east 00 St.
Peoria, Ariz. 85000

Neda Inspection Service LLC.

Date: 8/13/2007	Time: 1:00 PM	Report ID:
Property: 0000 east 00 St. Peoria, Ariz. 85000	Customer: Sample Report	Real Estate Professional:

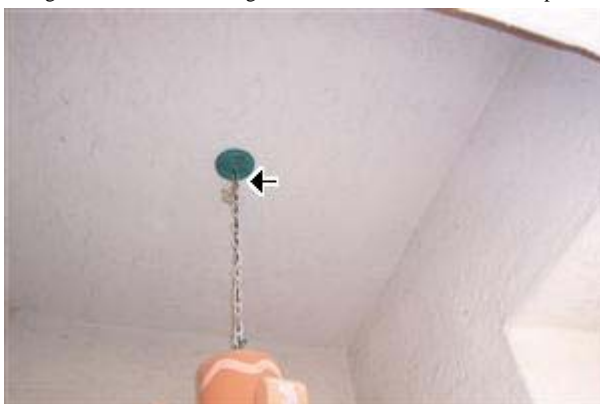
2.4 Picture 1

2.4 Patio ceiling has a crack along the joint. Recommend drywall repair. There is a spot where the caulking has come loose on the east end of the patio ceiling. Recommend resealing. There is a mud nest on the front porch light. Recommend removing.

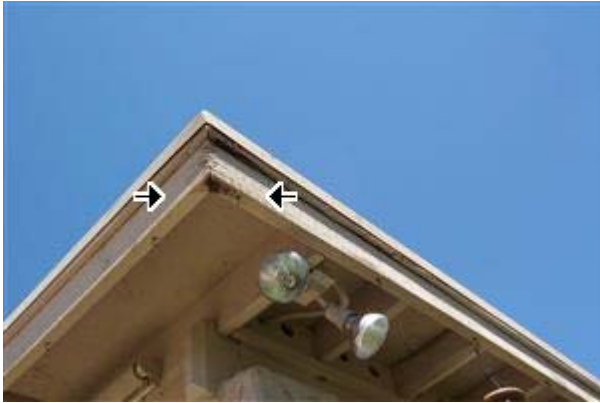
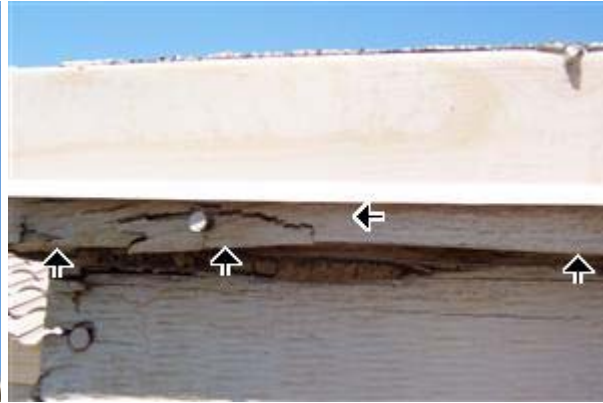
2.6 Picture 1

2.6 The fascia board on the west corner of the back patio has weather rot. There is a one by two under the flashing that is rotten in several spot across the

back of the patio. Recommend replacing the rotten fascia and the one by two.

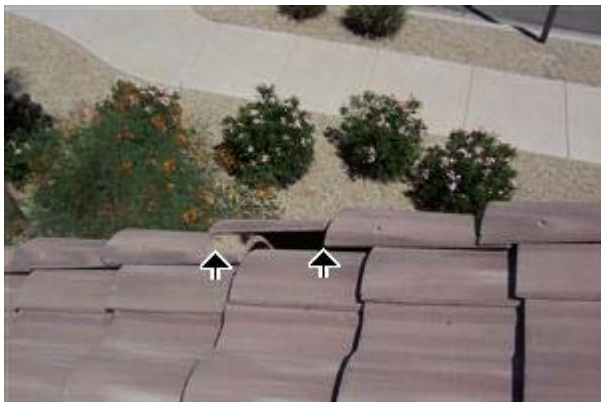
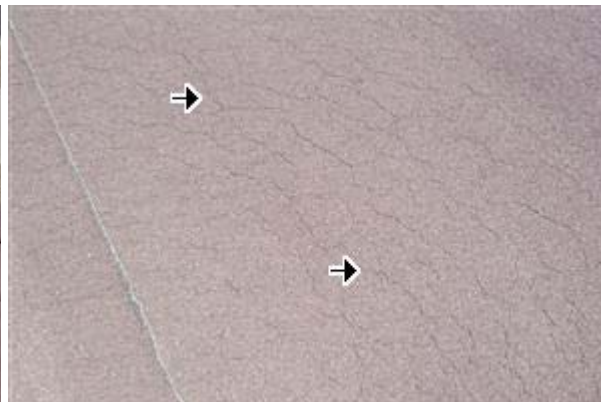
3.0 Picture 1

3.0 There is one broken tile on the front side west end of the house. The mortar on the ridge tile is cracked. Recommend replacing the broken tile and sealing the mortar crack. There are edge tiles that are missing on the eastside of the house. Recommend replacing. The rolled roofing on the back patio roof is showing age (cracking). Recommend adding roof coating to extend the life of the roof over the patio.

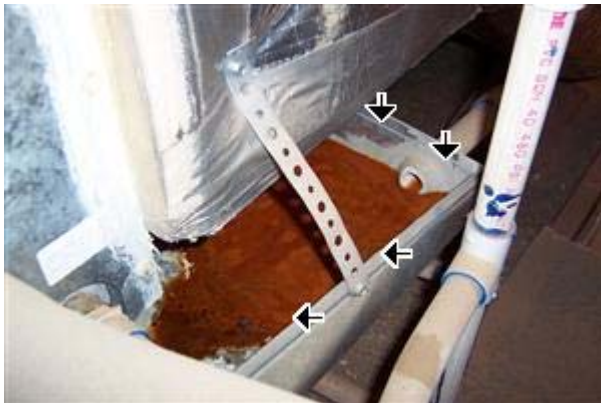
7.0 Picture 1

7.0 A/C disconnect is present. Condensate line is present. Condensation pan has water and rust in it; this could mean that the condensation line out of the air handler could be plugged. The supply air temperature on your system reads 68 degrees, and the return air temperature was 80 degrees. This is a 12 degree split. The split should be between 15 degrees and 22 degrees. This indicates the unit is not cooling properly and a licensed Heat/Air contractor should further evaluate and make repairs.

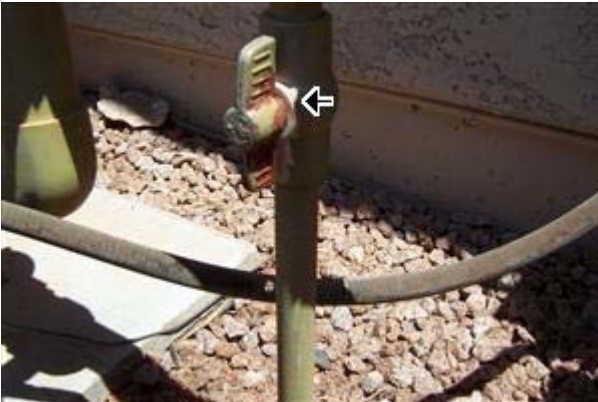
12.5 Picture 1

12.5 The valve for the aerator is leaking. Recommend replacing the valve.

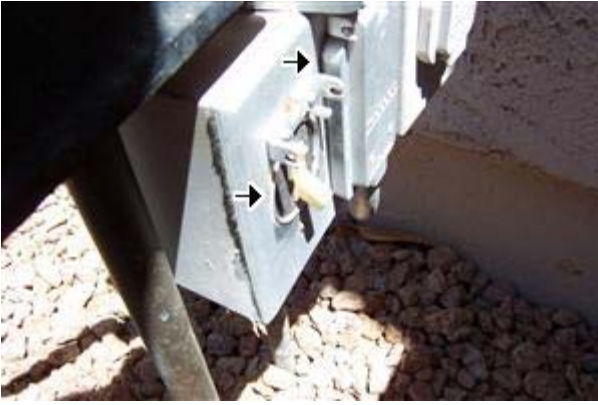
12.9 Picture 1

12.9 GFCI (Ground Fault Circuit Interrupter) is operational. Interior time clock cover plate is present. The cover plate for the light switch and GFCI outlet is broken. Recommend replacing the cover plate.

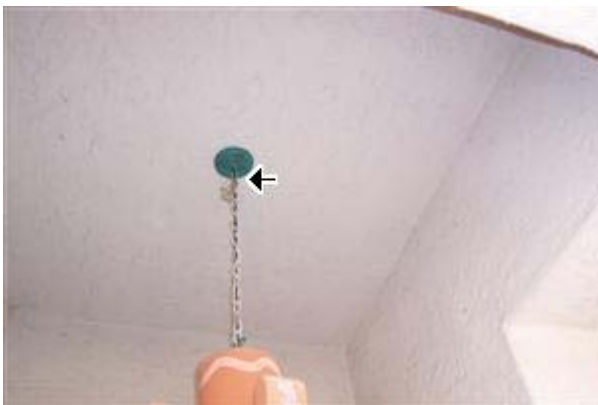
2.4 DECKS, BALCONIES, STOOPS, STEPS, AREAWAYS, PORCHES AND APPLICABLE RAILINGS

Patio ceiling has a crack along the joint. Recommend drywall repair. There is a spot where the caulking has come loose on the east end of the patio ceiling. Recommend resealing. There is a mud nest on the front porch light. Recommend removing.

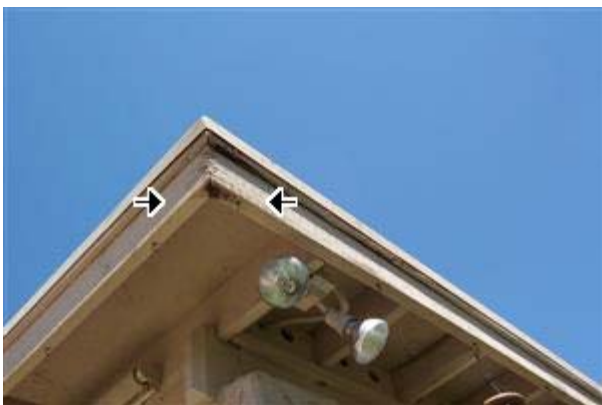
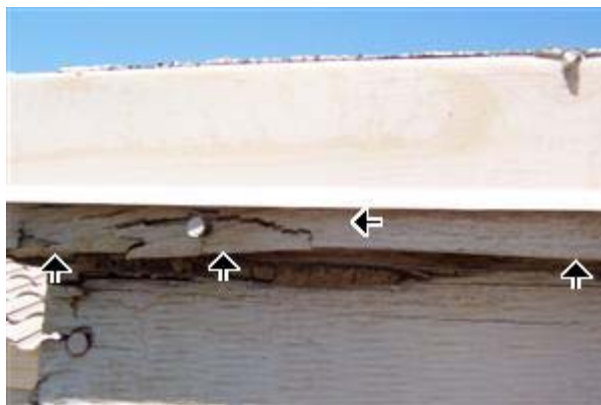
2.6 EAVES, SOFFITS AND FASCIAS

The fascia board on the west corner of the back patio has weather rot. There is a one by two under the flashing that is rotten in several spot across the back of the patio. Recommend replacing the rotten fascia and the one by two.

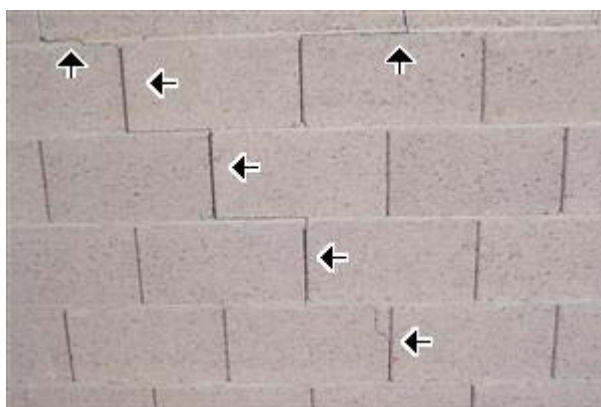
2.8 Fences

There are several loose blocks on the top row, east and west walls. There is joint cracking and a broken block on the west wall. Recommend repairing.

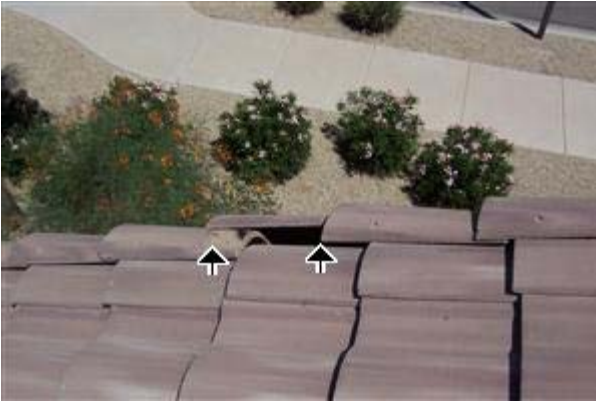
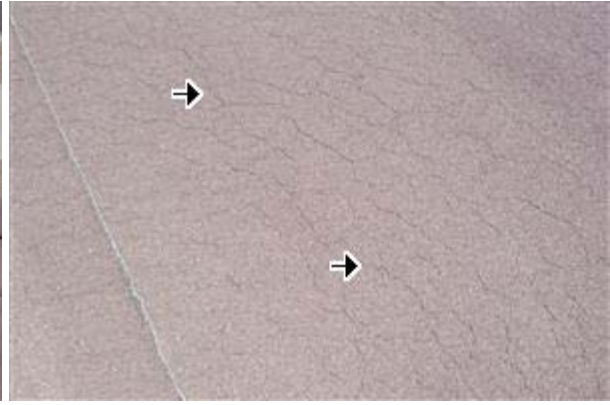
3.0 ROOF COVERINGS

There is one broken tile on the front side west end of the house. The mortar on the ridge tile is cracked. Recommend replacing the broken tile and sealing the mortar crack. There are edge tiles that are missing on the eastside of the house. Recommend replacing. The rolled roofing on the back patio roof is showing age (cracking). Recommend adding roof coating to extend the life of the roof over the patio.

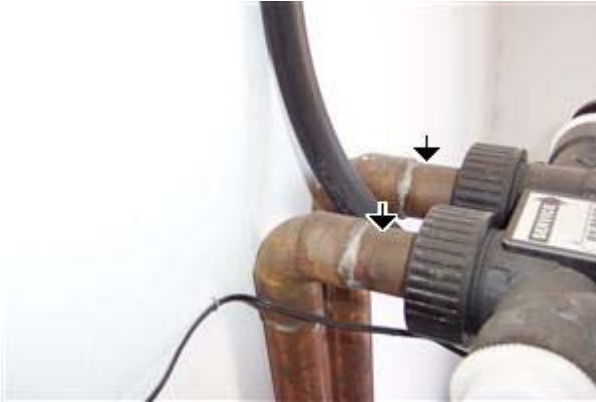
4.1 INTERIOR WATER SUPPLY AND DISTRIBUTION SYSTEMS AND FIXTURES

Functional flow is good. The hot water has low flow in the guest bath tub. The kitchen faucet is leaking at the base. Recommend having a licensed plumber make repairs. Hose bibb anti-siphon fitting missing (attention required). The water softener in the garage needs a bond wire between the two copper water lines going into the unit.

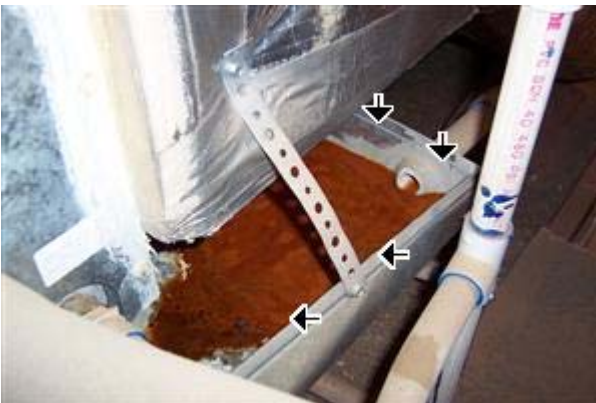
7.0 COOLING AND AIR HANDLER EQUIPMENT

A/C disconnect is present. Condensate line is present. Condensation pan has water and rust in it; this could mean that the condensation line out of the air handler could be plugged. The supply air temperature on your system reads 68 degrees, and the return air temperature was 80 degrees. This is a 12 degree split. The split should be between 15 degrees and 22 degrees. This indicates the unit is not cooling properly and a licensed Heat/Air contractor should further evaluate and make repairs.

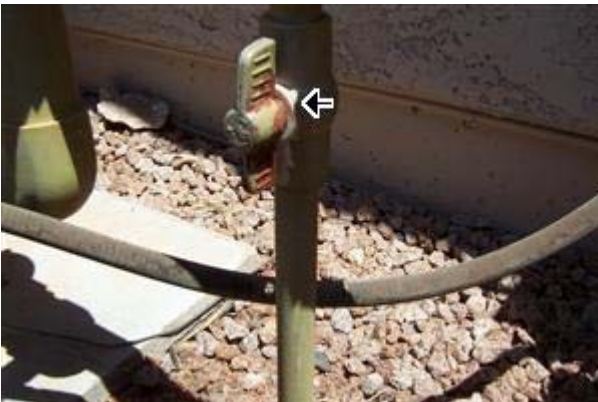
**12.5 PUMPS FOR CIRCULATION OF WATER**

The valve for the aerator is leaking. Recommend replacing the valve.
